1. REPORT DATE (DD-MM-YYYY) 28-02-2003		2. REPORT TYPE A005 DATA ITEM		3. DATES COVERED (From - To) 01-04-1998 TO 28-02-2003	
4. TITLE AND SUBTITLE FINAL REPORT for Contract DAAE07-98-C-M012 (PART 3 OF 3) -Evaluation of Alternate Driveshaft Configurations for the FMTV Program				5a. CONTRACT NUMBER DAAE07-98-C-M012	
				5b. GRANT NUMBER	
				5c. PROGRAM ELEMENT NUMBER	
				5d. PROJECT NUMBER

14. ABSTRACT EVALUATIONS OF CANDIDATE DRIVESHAFTS FOR THE FMTV PROGRAM FROM DANA, ARVIN MERITOR (2 DESIGNS), AND GKN WERE CONDUCTED. THE EVALUATIONS INCLUDED INSTRUMENTED ROAD TESTING, A 1000-MILE DURABILITY TEST THAT INCLUDED HIGH SPEED DRIVING AND SUBMERSION, LABORATORY MEASUREMENTS, AND DADS MODELING. THE DRIVESHAFTS WERE (UN)BALANCED TO THEIR MANUFACTURERS PRODUCTION LIMITS PRIOR TO EVALUATION AND THEN TESTED ON THE VEHICLE USING A SPECIAL TRANSFER CASE TRANSDUCER CAPABLE OF MEASURING DRIVESHAFT DYNAMIC FORCES. A PRINCIPLE FOCUS OF THE PROGRAM INCLUDED SEVERAL METHODS OF MEASURING INSTALLED CRITICAL SPEED.

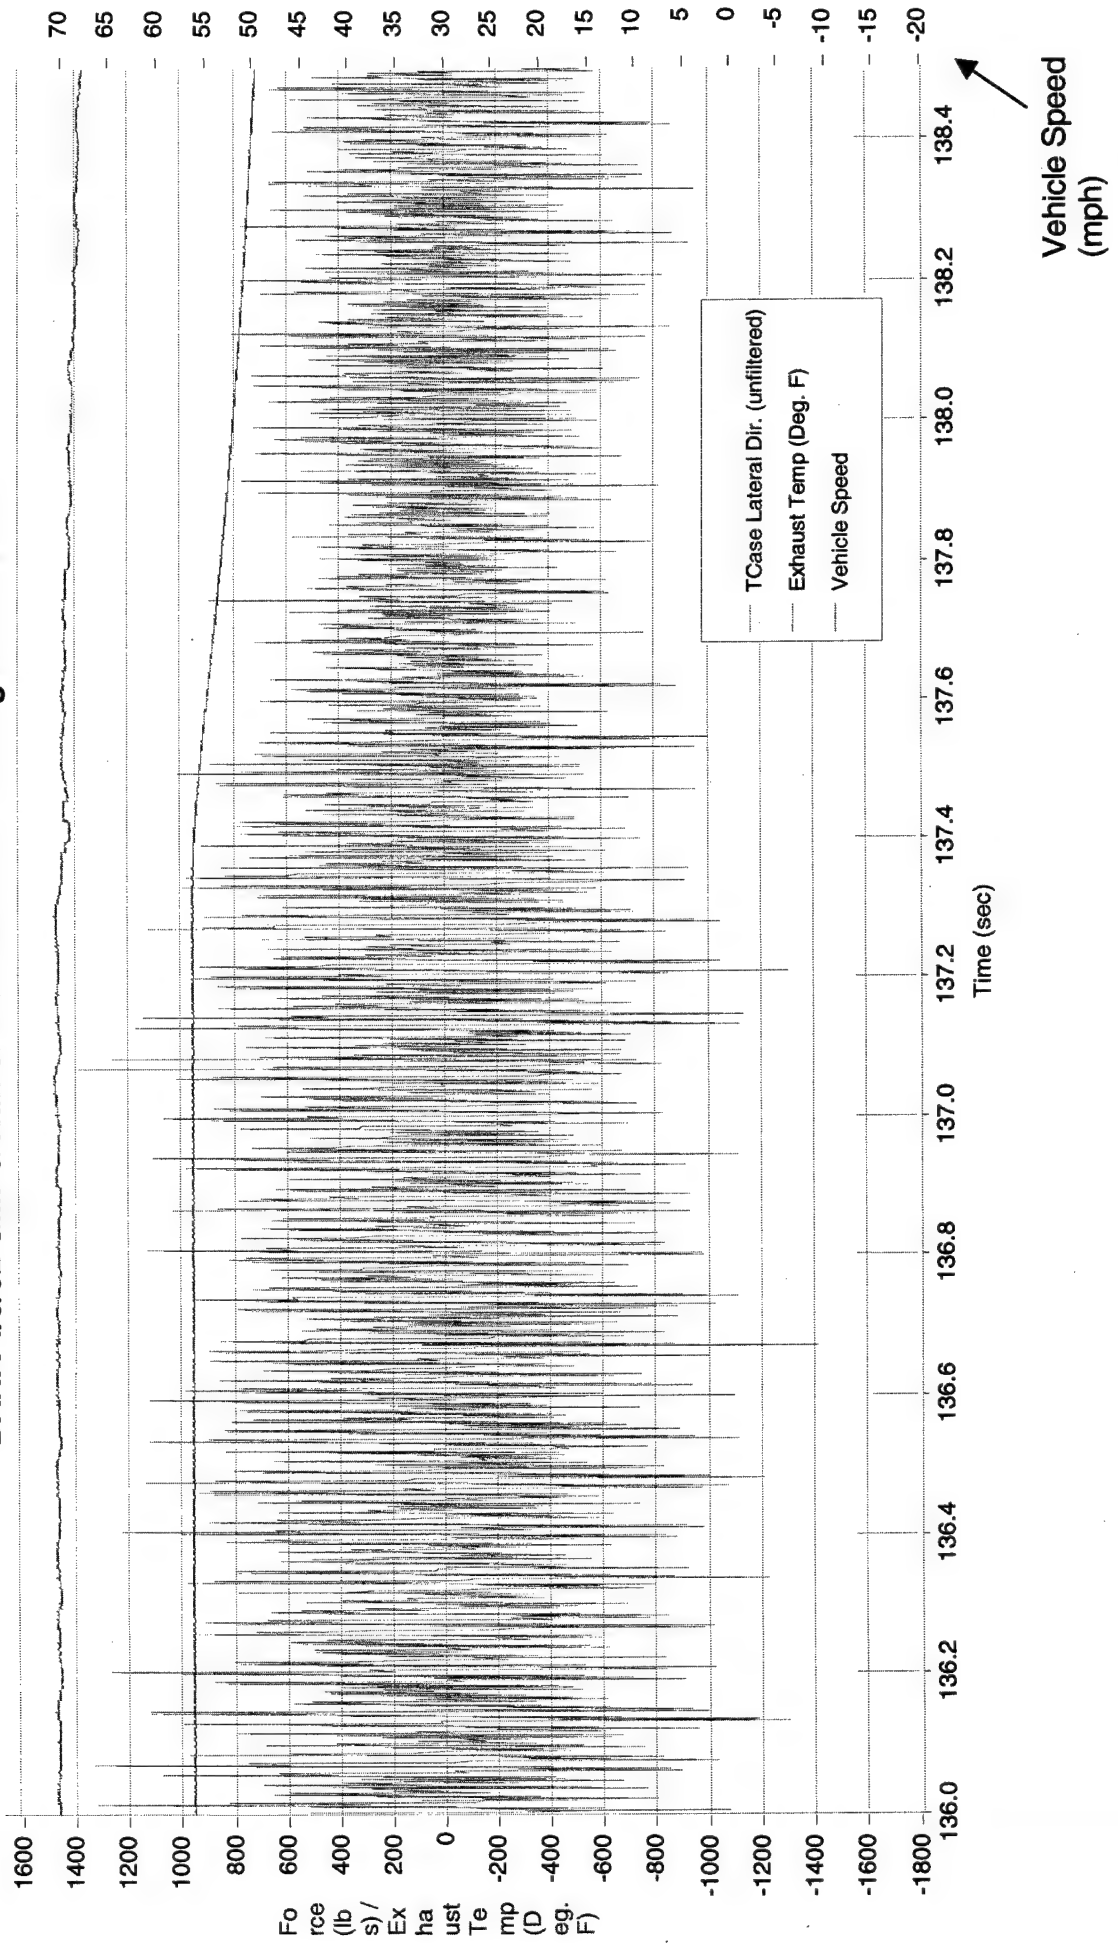
Figure 6

DANA 4/3/02 GMPG Run 6: Transfer Case Housing Lateral Force

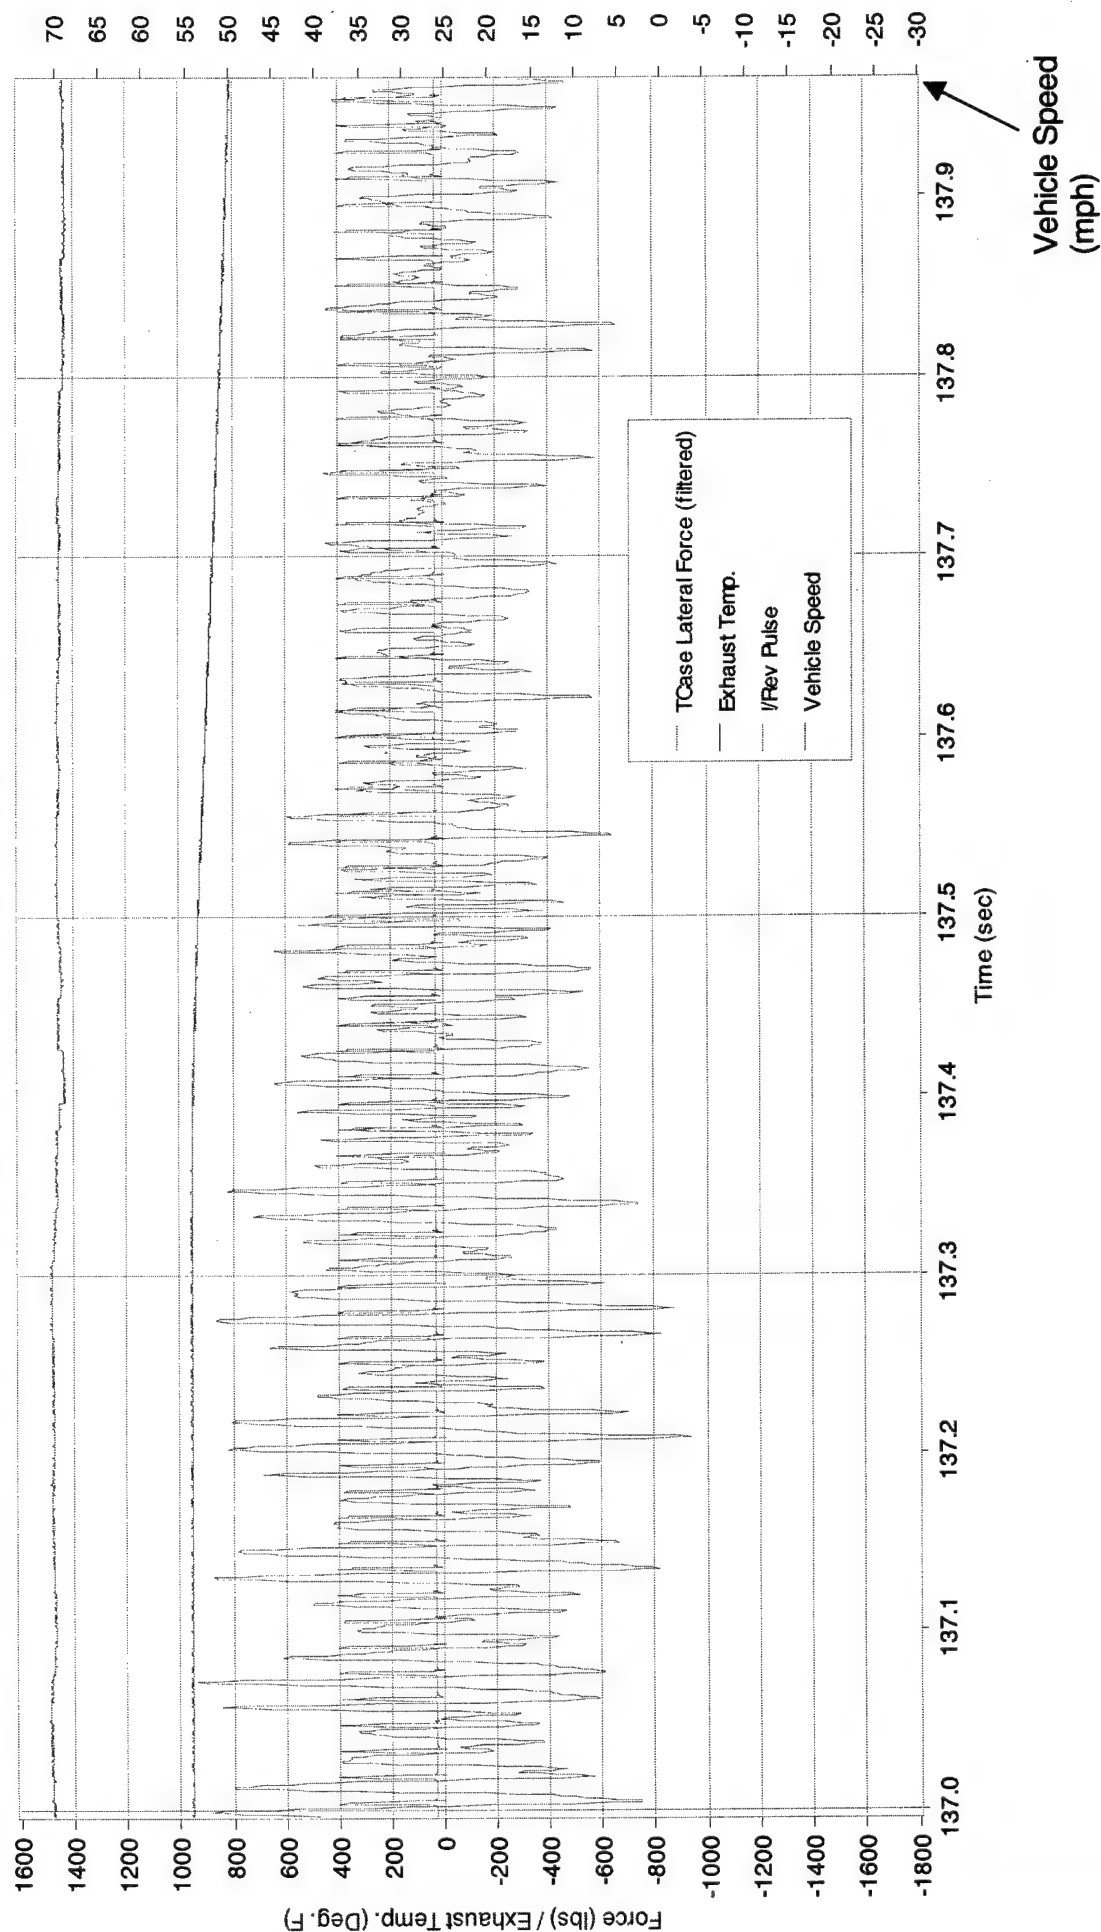
Figure 8

DANA 4/3/02 GMPG Run 6: Transfer Case Housing Lateral Force (Filtered at 200 Hz)

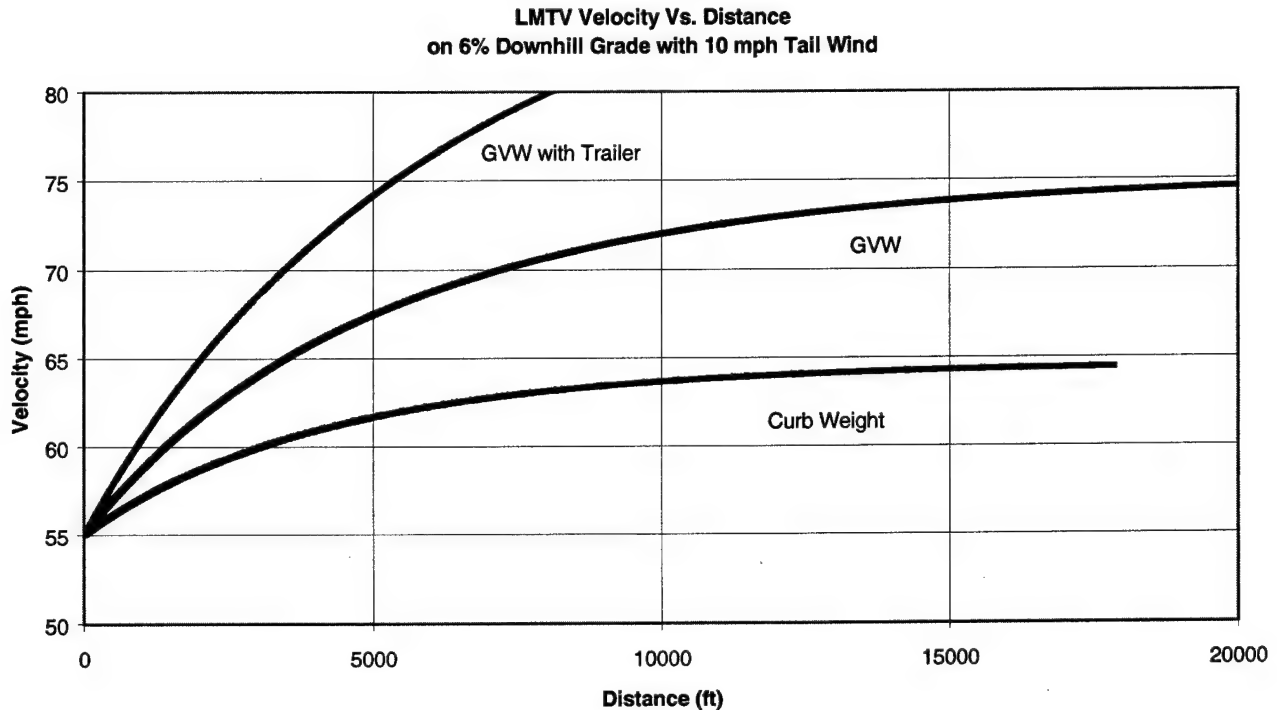
Figure 12

A typical output chart from the model is shown in Figure 12.

It can be seen that an LMTV at GVW, can easily achieve 70 mph on grades found on the US interstate highway system. The A0 vehicles were built with no engine braking hardware. The A1 vehicles have an engine exhaust brake, which can be turned off by the driver. This analysis is representative of all A0 vehicles as well as the A1 vehicles with the exhaust brake off. The use of a trailer further increases speeds.

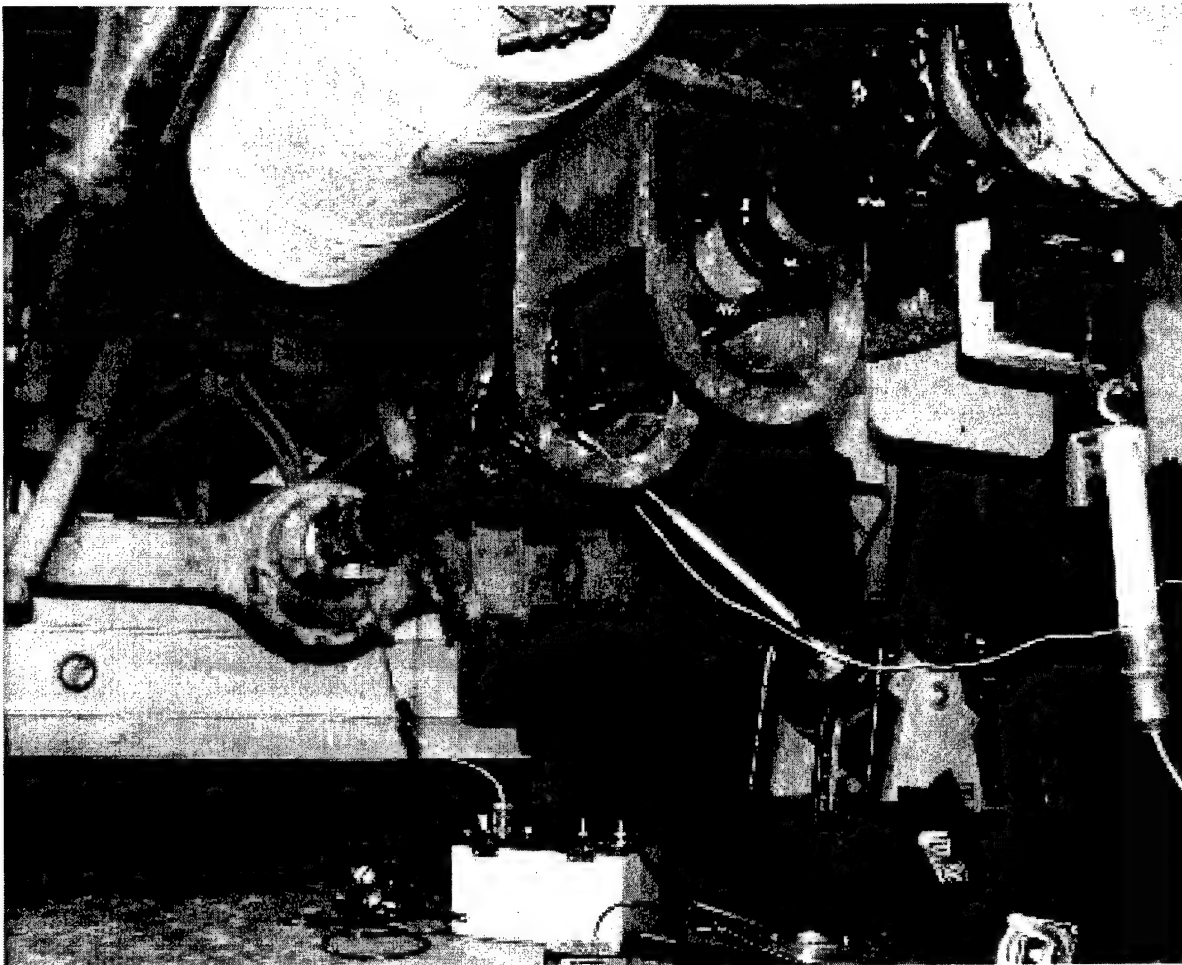
The most accurate measurement of critical speed is to actually drive up to, and through critical speed in the vehicle and observe the response of the driveshaft and vehicle with data measurements. In vehicles that meet SAE design guidelines, though, the vehicle will not achieve speeds high enough to reach driveshaft critical speed.

Figure 13 In-Vehicle Shaker Test

It is necessary to provide guards to prevent excessive vehicle damage if the vehicle is to be driven near critical speed. The LMTV was fitted with appropriate guards and measurement channels for this test.

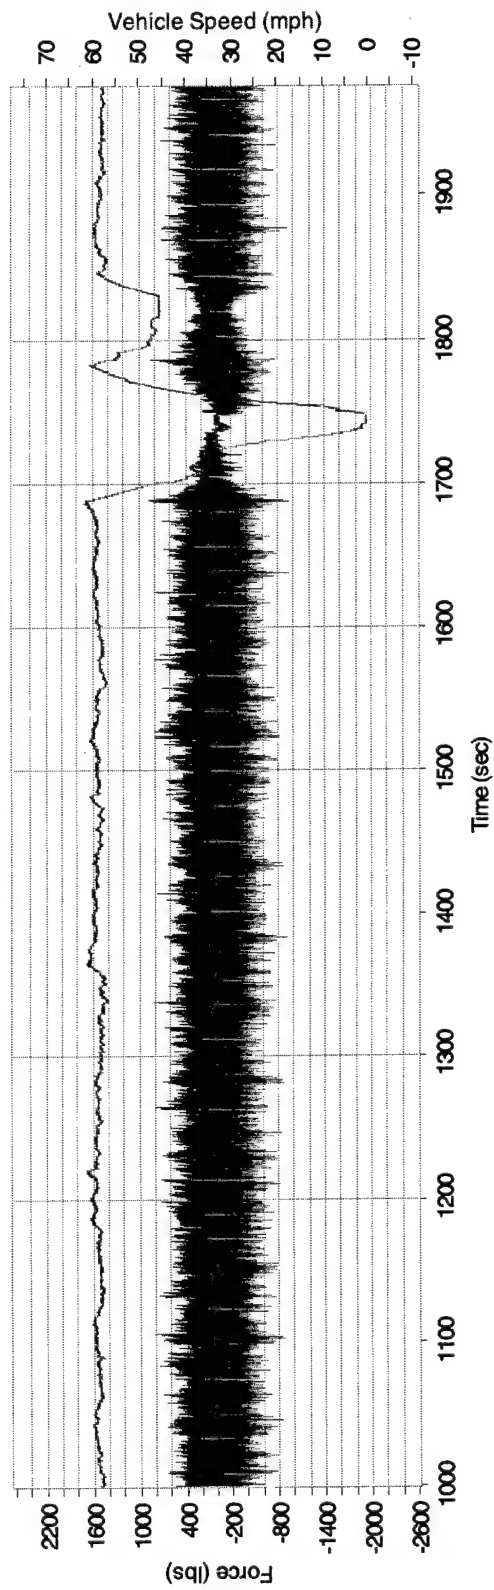
MTV A1 (8/21/02 test): Transfer Case Housing Vertical Force

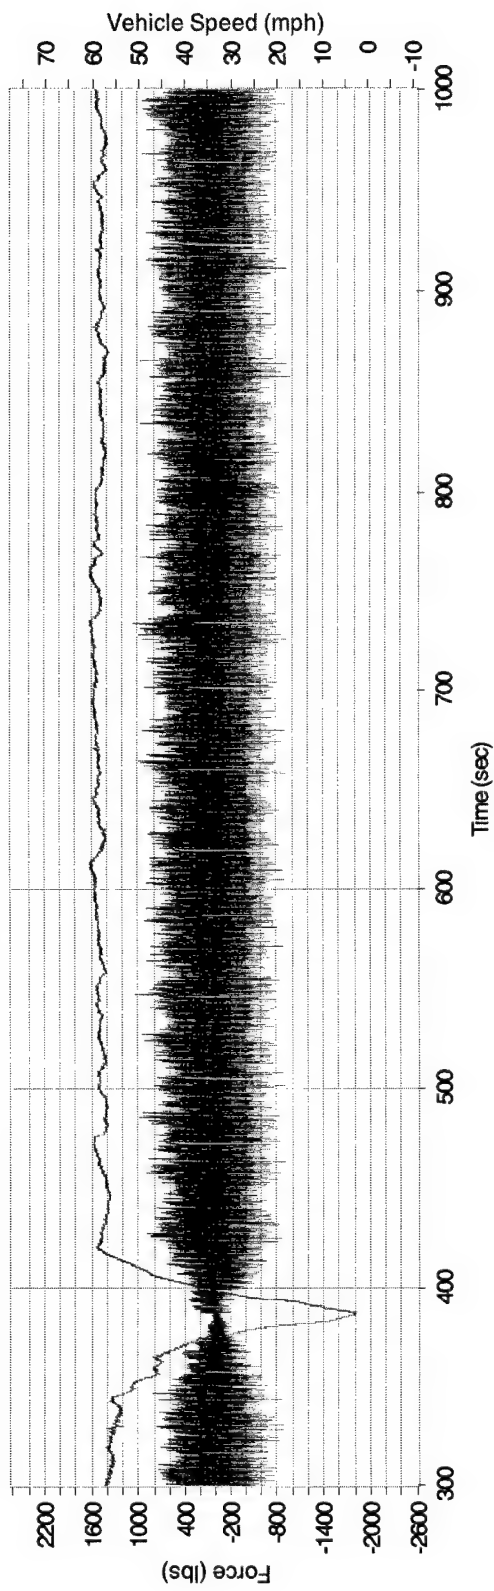
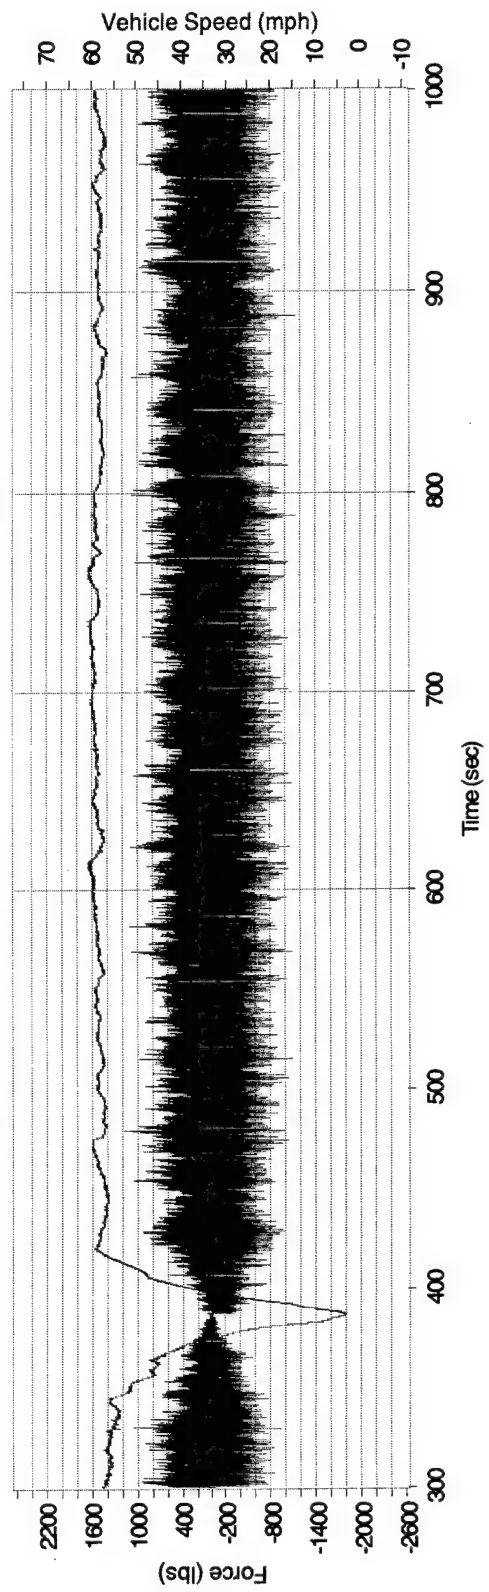
Figure 27

MTV FPL20 (8/13/02 test): Transfer Case Housing Lateral Force

MTV FPL20 (8/13/02 test): Transfer Case Housing Vertical Force

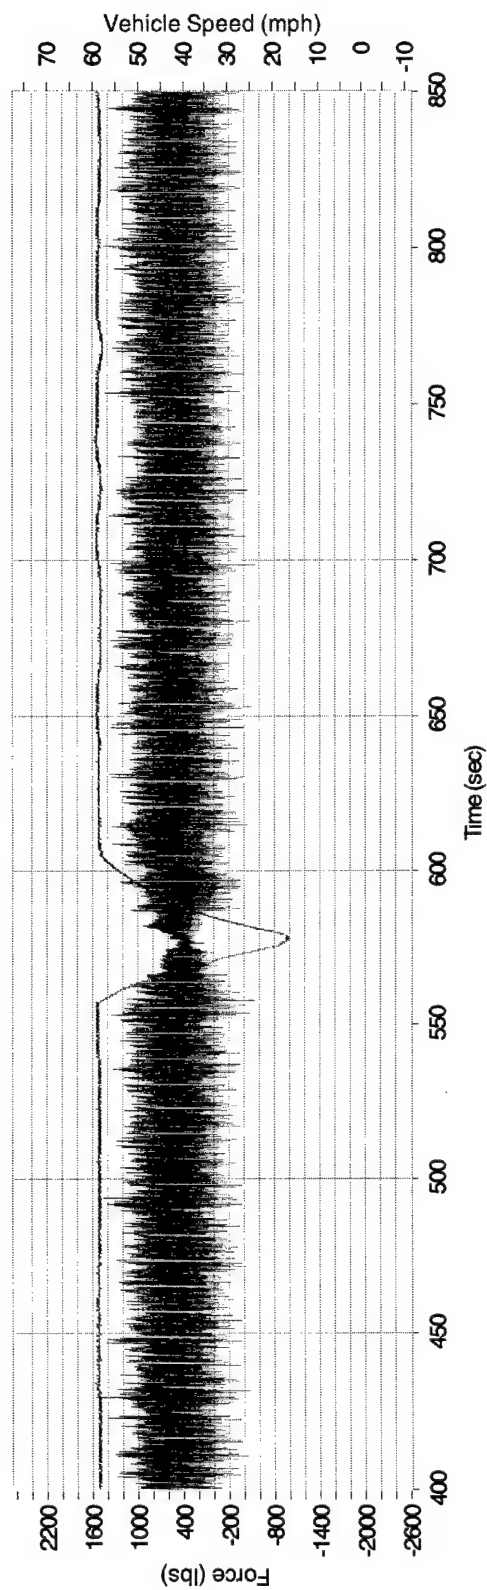
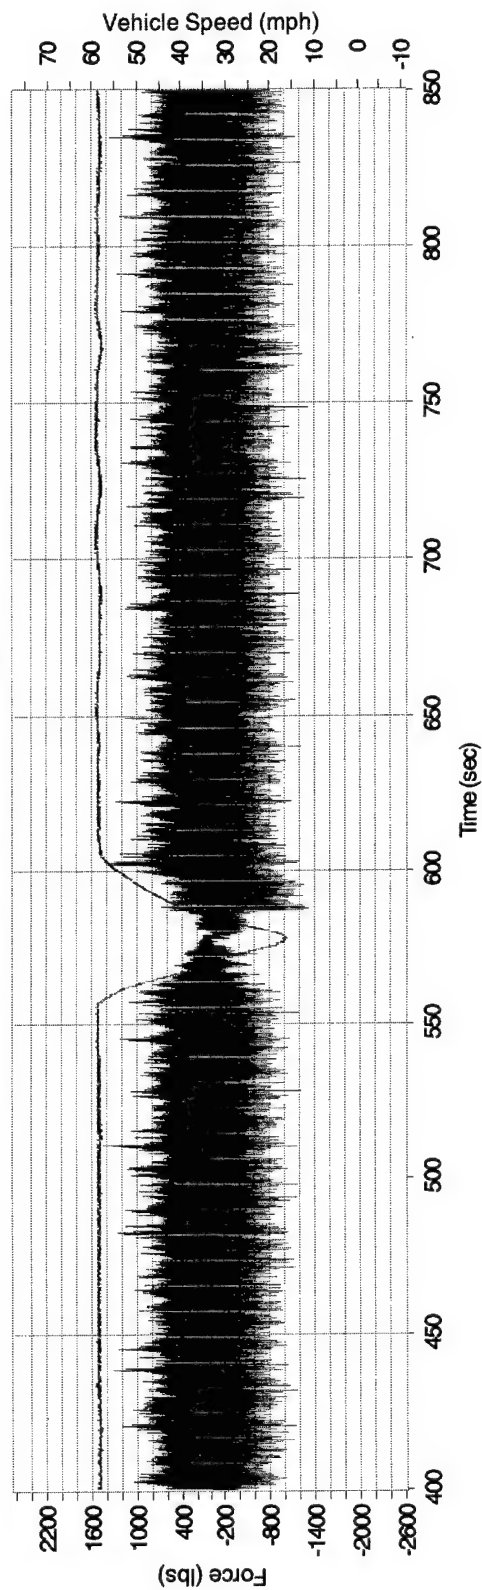
Figure 28

MTV DANA (7/26/02): Transfer Case Housing Lateral Force

MTV DANA (7/26/02): Transfer Case Housing Vertical Force

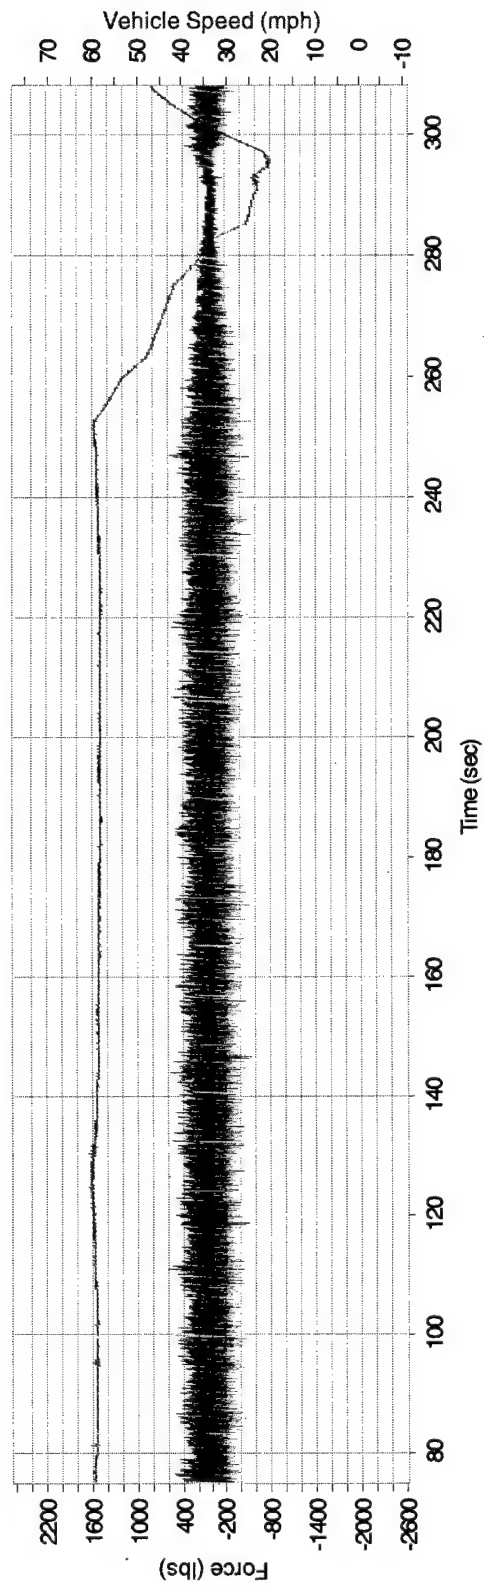
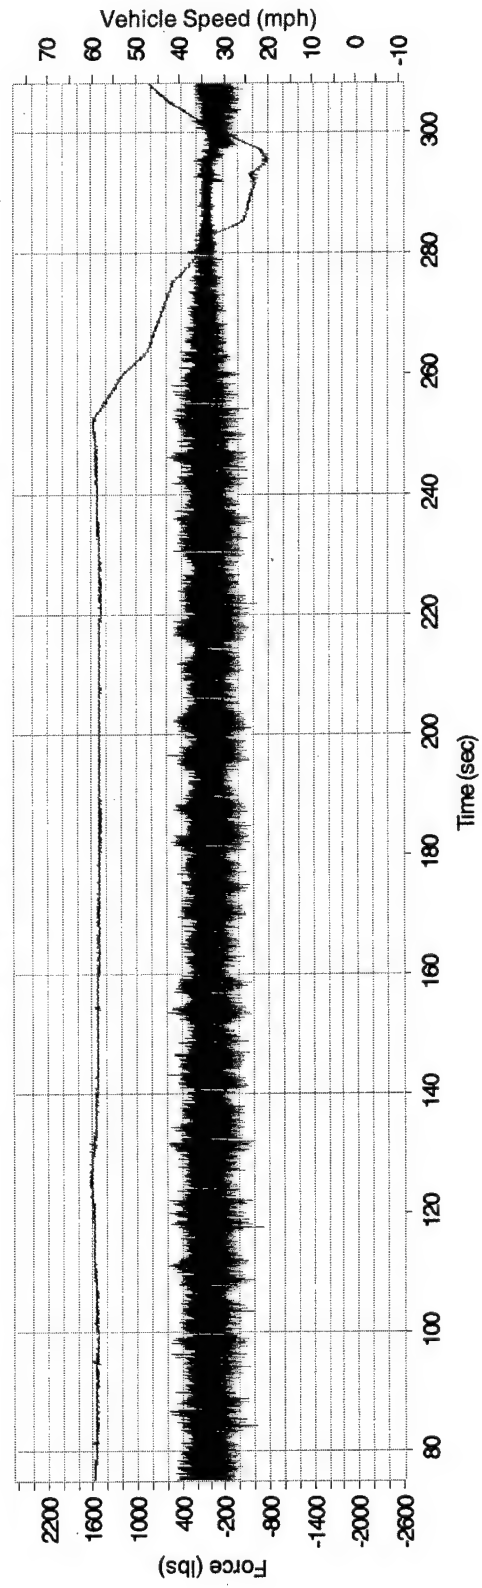
Figure 29

MTV GKN (7/17/02 test): Transfer Case Housing Lateral Force

MTV GKN (7/17/02 test): Transfer Case Housing Vertical Force

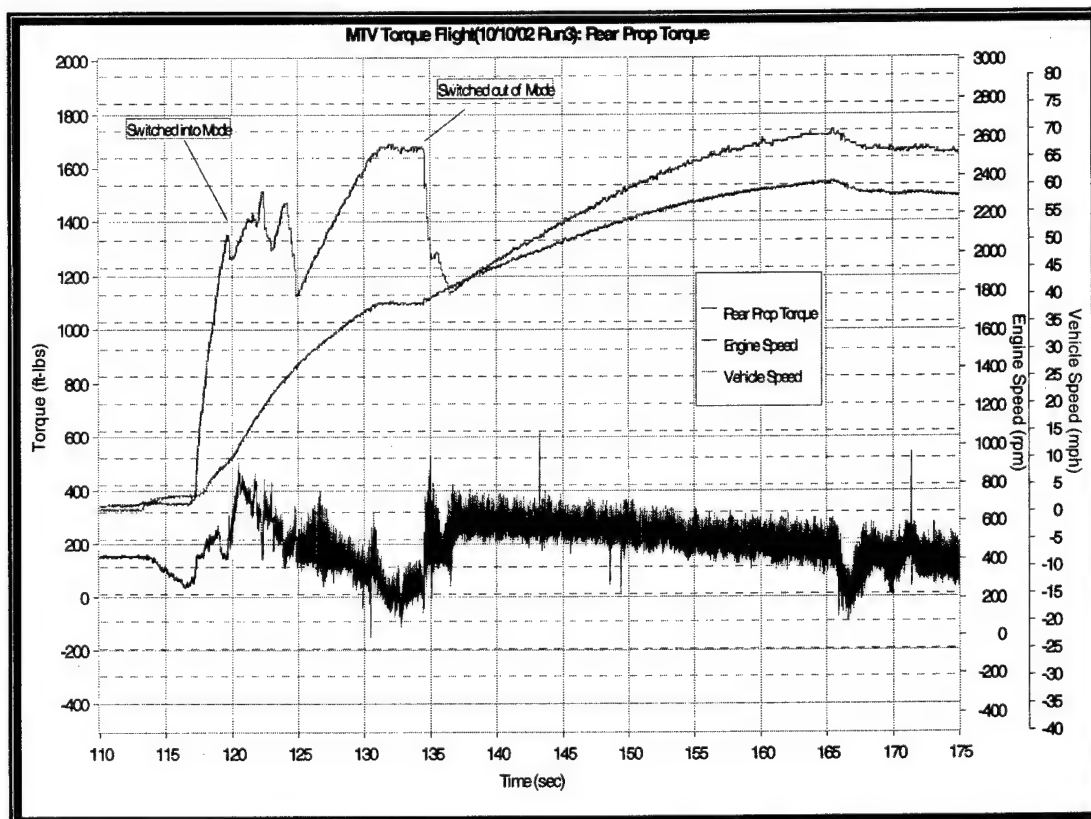
Figure N
Typical MTV Rear-Rear Driveshaft Data

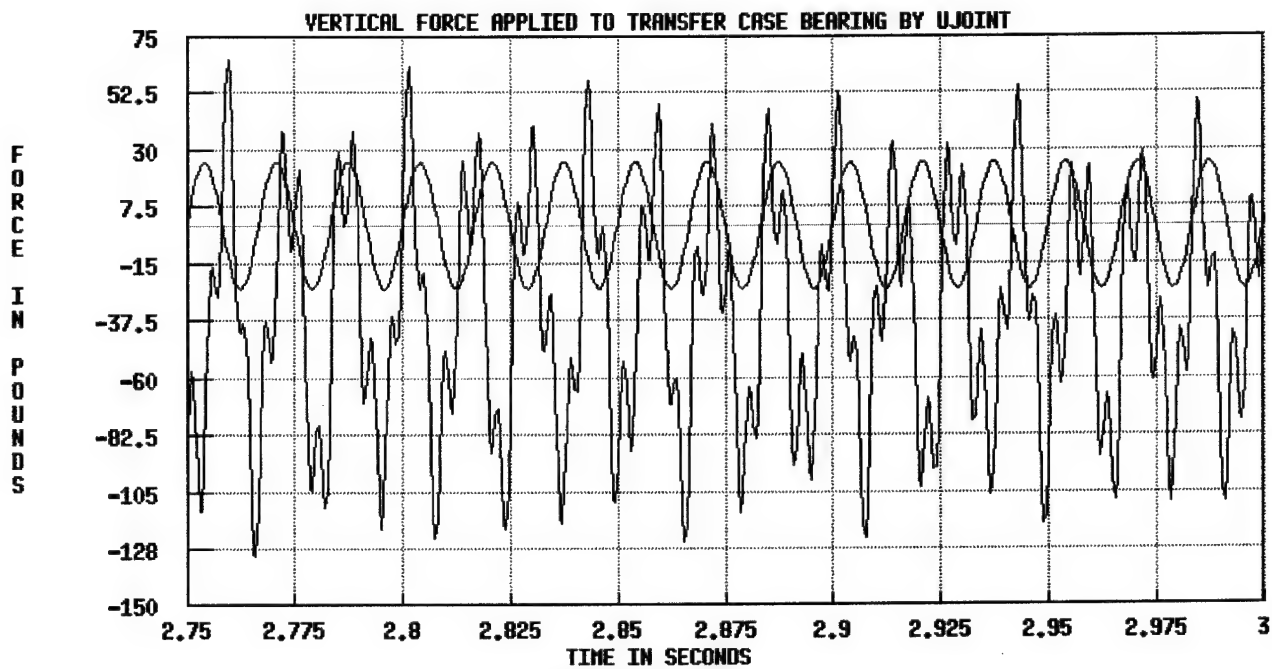
FIGURE 1

The vertical force trace for V20srVCSgb0ubgbrs.def, figure1, shows a complex waveform with elements related to the rotational speeds and with a signal changing faster than the rotational speed. Its FFT, figure2, shows a signal at the critical speed of 71 HZ, the residual response to the startup transient. It shows weaker signals at the second and fourth orders of rotational speed. These are generated by the twice per revolution rotational acceleration and deceleration of the shafts inertia due to ujoint's operating angle. Both of these signal sources will be treated in more detail later. The addition of unbalance (V20srVCSgb1ubgbrs.def) adds a very strong component at first order of revolution. The force trace, figure3, shows a beat between that and the residual response to the startup transient. The amplitude of the residual response and that due to the rotational acceleration/deceleration remains about the same as shown by both FFTs. The amplitude of the once per revolution caused by the unbalance is the dominant signal in the second FFT, figure 4.

This next comparison is between the pair V20srVCSgb0ubgbrs.def (figures 1 and 2 in the previous group) and V20vIrVCSgb0ubgbrs.def. The run time was increased for the run

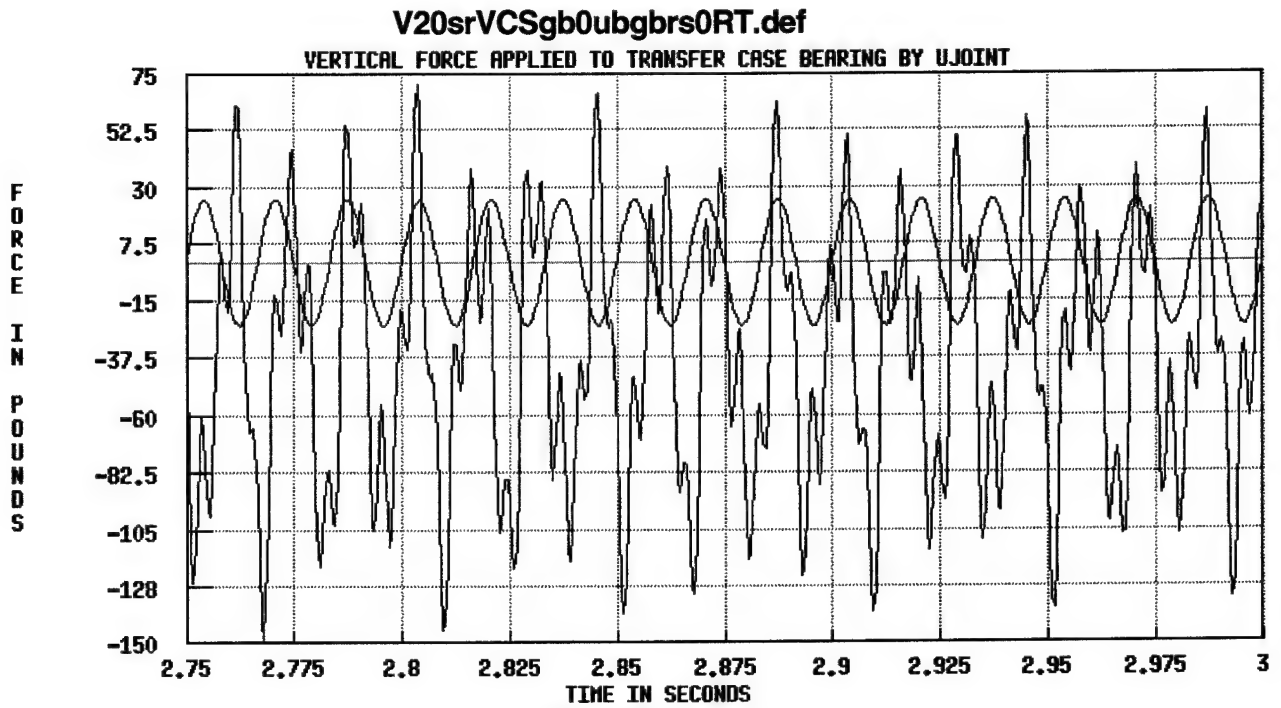
FIGURE 7

The vertical force trace for V20srVCSgb0ubgbrs0RT.def, figure 7, (no load torque) shows a complex waveform. It's FFT, figure 8, shows it is comprised of signals at 70.3 Hz @ 35.8 units of amplitude, 120 Hz @ 7.8 units and 240 Hz @ 17 units. The 70.3 Hz signal is, as described earlier, the residual response from the startup transient. The 120 Hz and 240 Hz signals are from the second and fourth order forces generated by the twice per revolution rotational acceleration and deceleration of the shaft. The driving torque graph, figure 9, shows that twice per revolution torque. Note that it is symmetric around the zero axis.

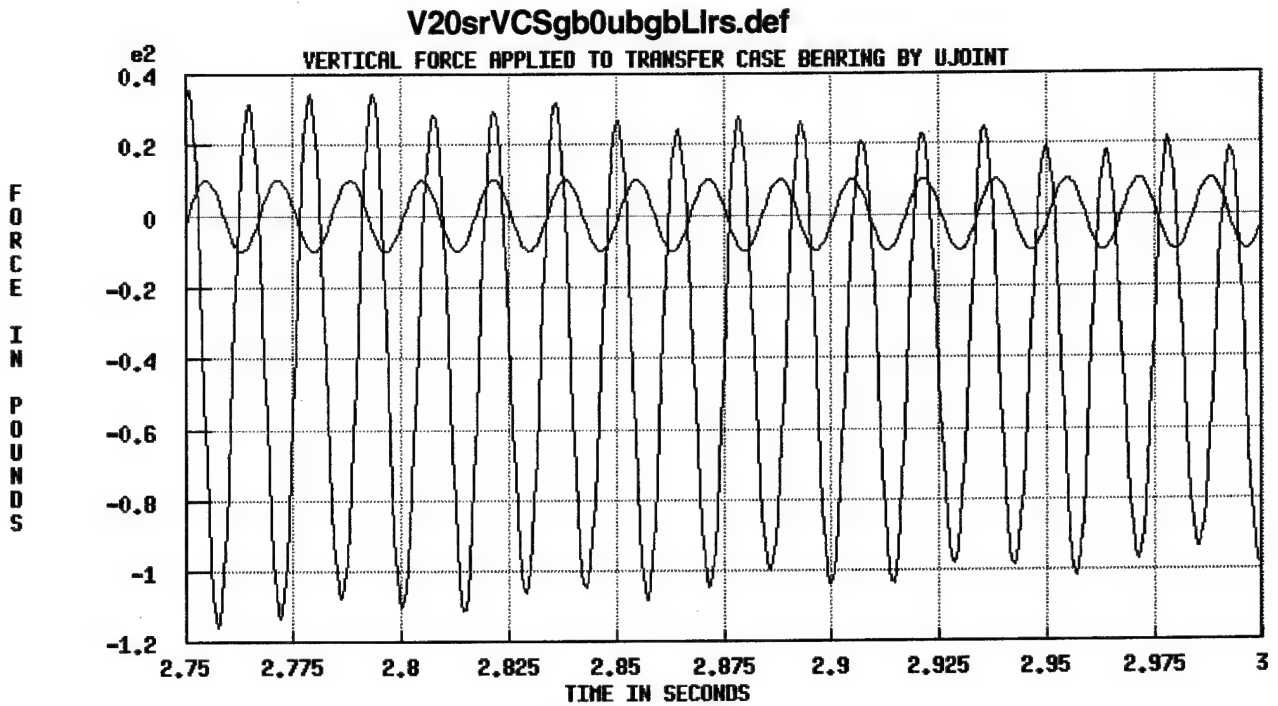
FIGURE 16

In run V20srVCSgb0ubgbLlrs.def, figure 16, (low shaft inertia) the vertical force is about 140 lbs. peak to peak. This is somewhat lower than with the standard inertia. The force is biased negatively due to the static weight of the shaft. Note that the force is not locked to rotation. The force FFT, figure 17, shows a peak at 70.3 Hz from the residual response to the startup transient. It also shows a weak peak at 120 Hz, second order of rotation. The driving torque, figure 18, applied to the tube is about 56 in-lbs. peak to peak biased upwards by the 240 in-lbs. drag torque. It is a second order signal.

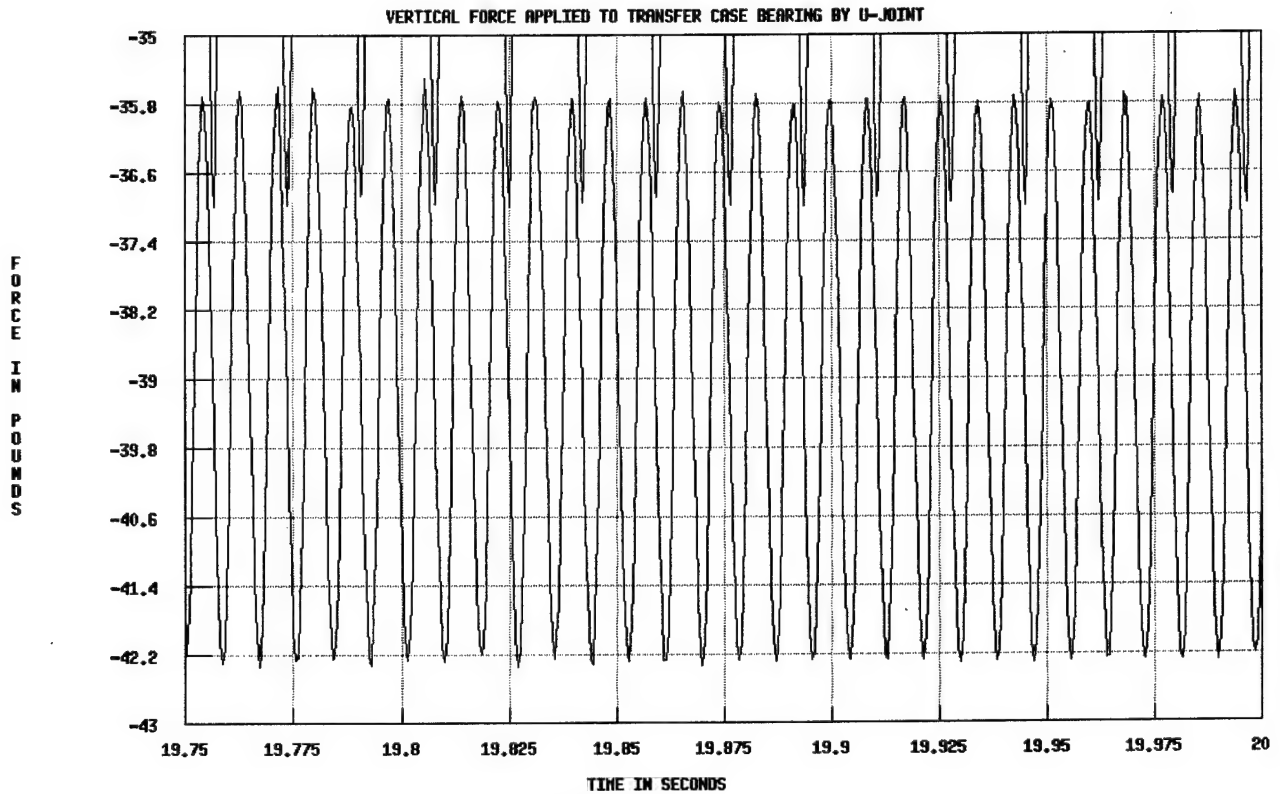
FIGURE 25

Both vertical force traces show the vertical force bias due to gravity of about 39 plus lbs. The force trace for the run with drag torque, figure 25, is the sum of the reaction components to both drag torque and the twice per rev shaft velocity change. The AC force is about 7-lbs. peak to peak, predominately second order. The AC force for the run without drag torque, figure 28, is about 0.4 lbs. peak to peak, predominately fourth order. The required driving torque, figure 27, for the run with drag has a 56 in-LB peak to peak second order AC component added to a 240 in-lbs. DC component. The required driving torque without drag, figure 30, is also 56 in-lbs. peak to peak second order AC without a DC component. The FFT for the run with drag, figure 26, shows a second order component and a weaker fourth order. The no drag FFT, figure 29, shows weak second and fourth order components from the low shaft inertia being accelerated twice per rev. However the fourth order is about twice the second order component.

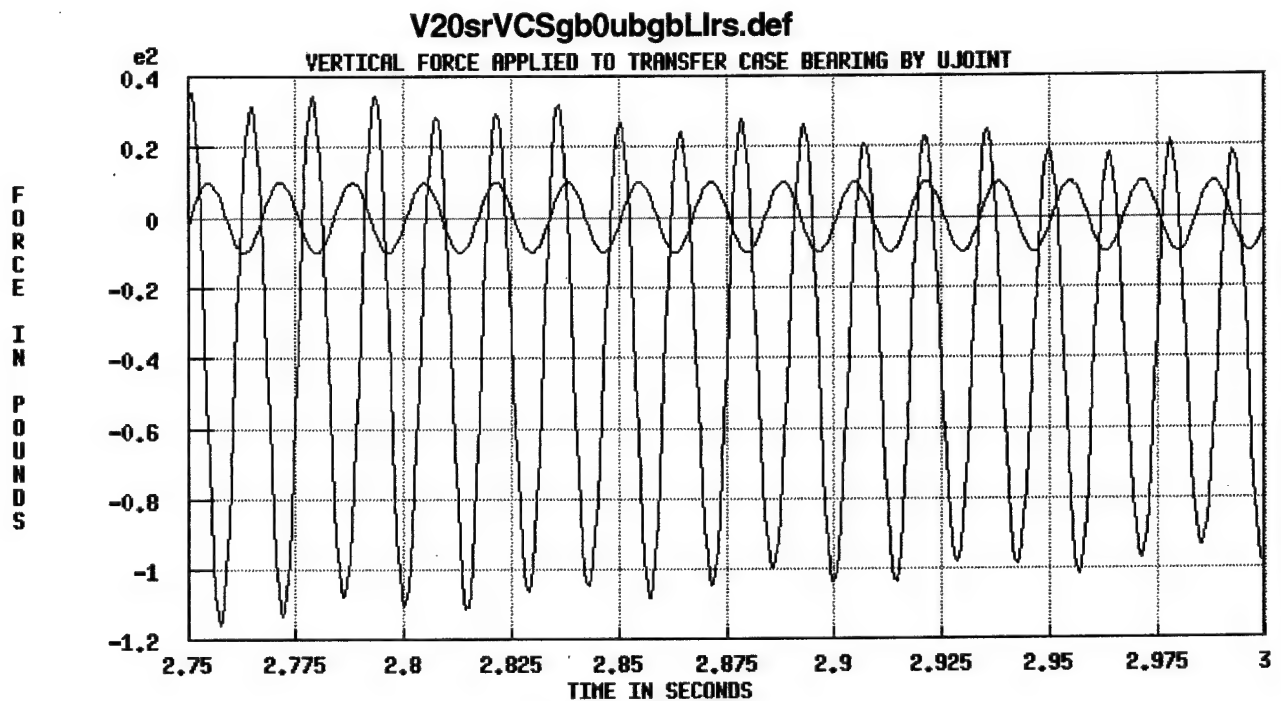
FIGURE 31

Figure 31 shows a decaying response to the startup transient with an additional second order force. This is also shown by its FFT, figure 32. Figure 33 shows the second order driving torque required by the drag torque and small shaft inertia. Figure 34 displays a more complex force waveform with a strong beat pattern. Figure 35, its FFT, shows a large component at 60 Hz caused by the unbalance. The component at 70 + Hz from the decaying response to the startup transient has increased by 25 % but is less than half of the 60 Hz component. These two are the source of the beat. The magnitude of the residual response is consistent with that generated by broad band noise input to the drive train. The second and fourth order components are nearly unchanged between the two runs, however addition of the unbalance has added a slight third order component.

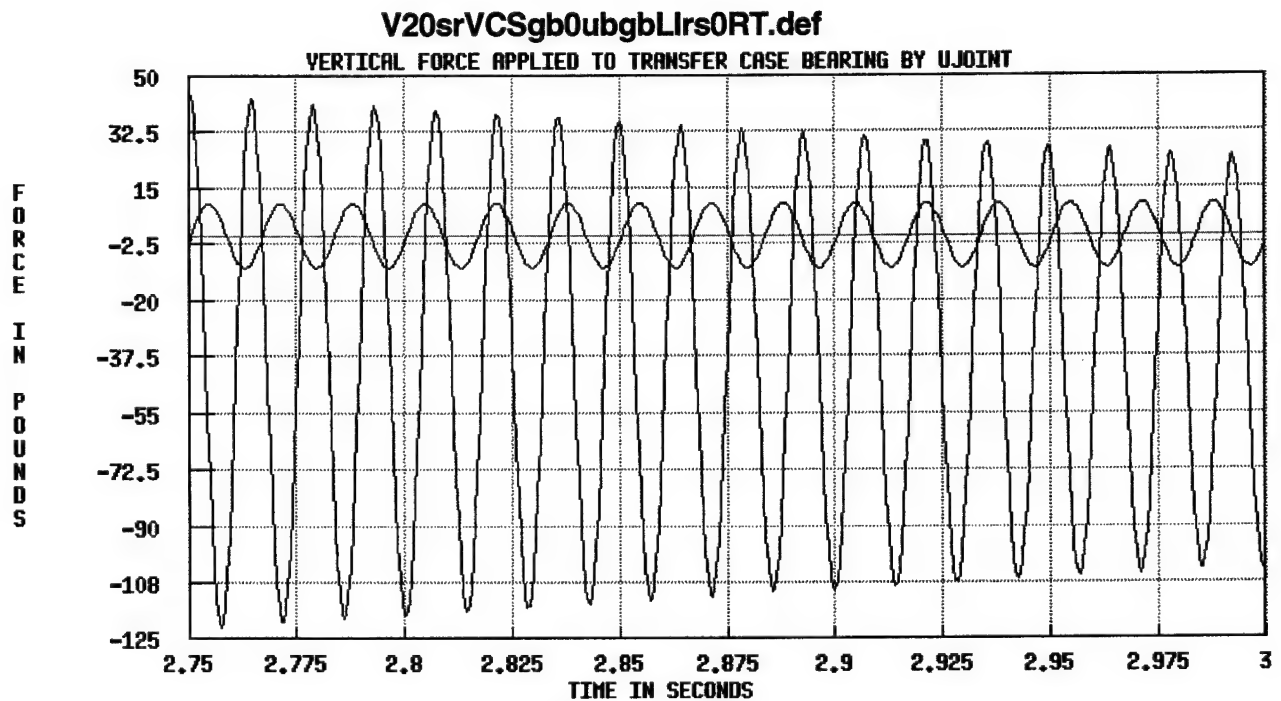
FIGURE 37

The run that generated figures 37, 38 and 39 used low shaft inertia and no drag torque. The decaying response is present. Figures 40, 41 and 42 below are repeated from comparison group seven. Their generator also had low shaft inertia and no drag torque. However the residual response is fully decayed. Additional comments follow the graphs.

Figure 37, the force trace, shows the signature of the decaying transient. Its FFT, figure 38, confirms that it is the strongest signal present. A zoomed FFT, not shown, shows small levels of signal at second and fourth order. A small signal also appears at slightly above third order. Figure 39, the driving torque signal, is clearly second order, not related to the transient. It is about 56.1 in-lbs. peak-to-peak. It is the torque required to accelerate and decelerate the small shaft inertia as well as replace energy dissipated in damping. Figure 40 shows the forces after the startup transient has fully decayed. It is a mixture of second and fourth order at low magnitude. A zoomed FFT, figure 41, shows low levels of second and fourth order. These are about half of their counterparts discussed above. Also there is no energy around third order. The driving torque signal, figure 42, is about 52.7 in-lbs. peak-to-peak. System geometry changes as the startup transient decays and less energy is dissipated in damping.

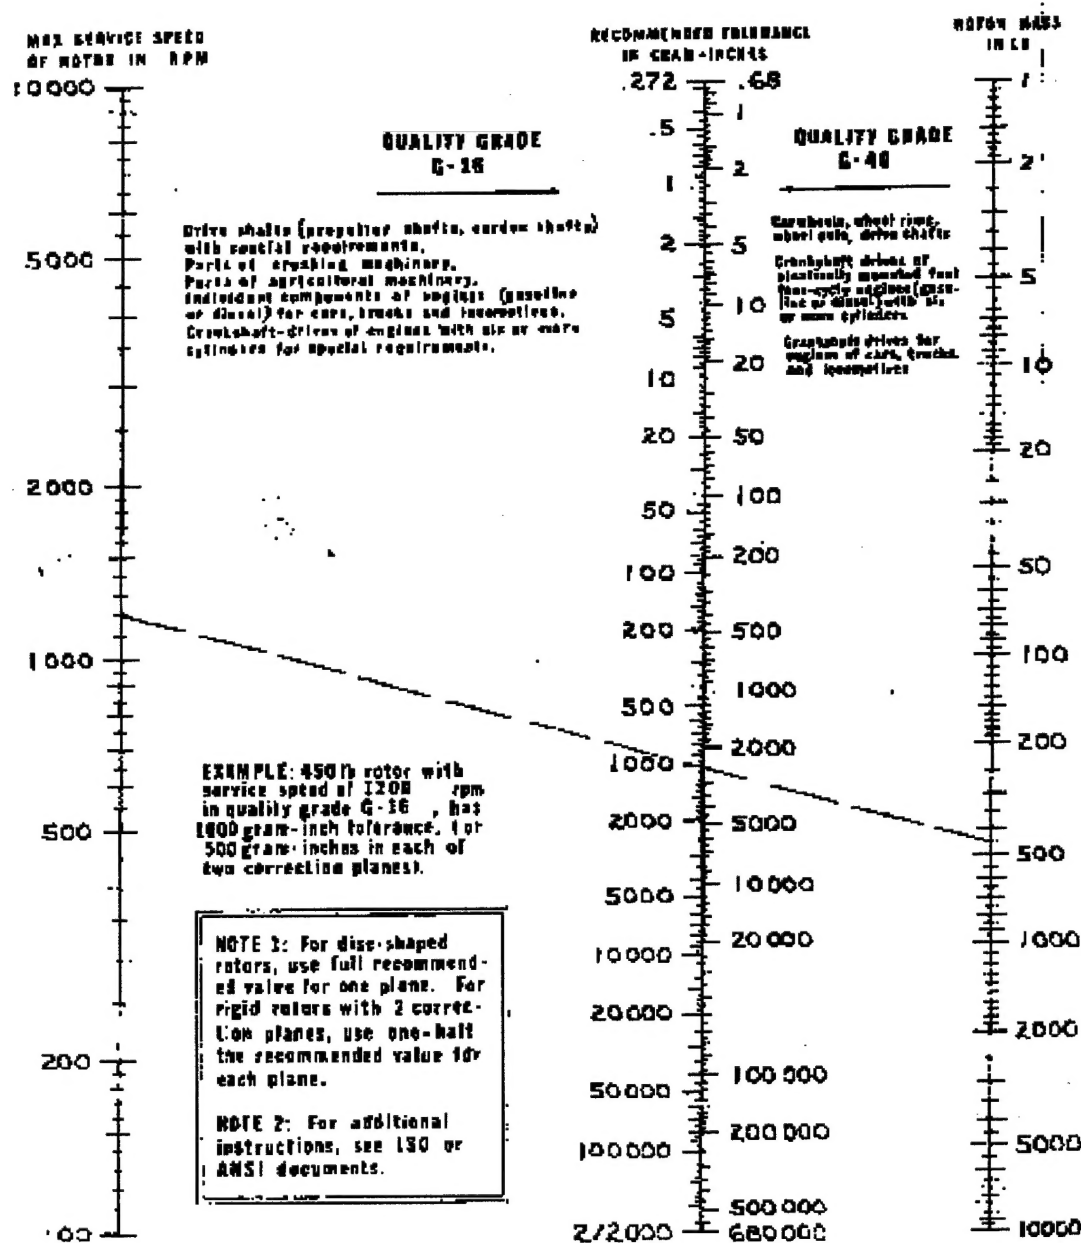
Fig 5-9 BALANCE TOLERANCE NOMOGRAM FOR G 16 & G 40

Based on ISO 1909, and ANSI Z2.19
